BEHAVIOR AND THE MECHANISM OF WATER LEAKAGE OF CANYON TUNNEL AT KIRIWANELIYA

D. M. G. S. Dassanayake¹, Jagath Gunatilake¹ and Laxman Galagedera²

¹*Department of Geology, Faculty of Science, University of Peradeniya*

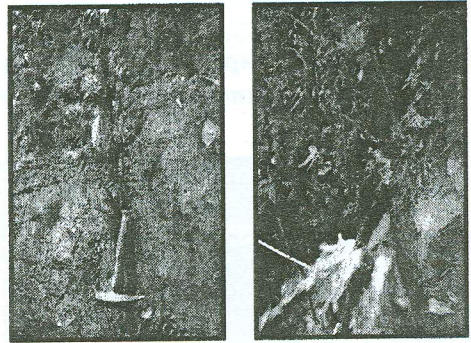
The Canyon Tunnel, diverting water from Canyon Reservoir to the New Laxapana Powerhouse has created a major leakage at Kiriwaneliya area several years after its commissioning. The leakage which remained insignificant at early stages has grown to a critical stage at present. Occurrence of several major leakage outlets in the area shows that the amount and the intensity of the leakage is significantly high (Figure 1).

Figure 1. Some of the leakage outlets emerging out from the cliff behind the valve house of the Canyon Tunnel

It was concluded that the ingress zones of tunnel leakage exist along a section of the tunnel upstream of the surge chamber where it cross cut the fault zone 6. Considering all geotechnical, geological and structural conditions of the Canyon Tunnel and the sub surface conditions at Kiriwaneliya area, it is strongly recommended to seal the discontinuities on the tunnel walls specifically between the distance 500 m – 600 m (just upstream of the surge chamber) by appropriate remedial measures (most suitably concrete plugging, grouting or shotcreting) after controlled dewatering of the tunnel.

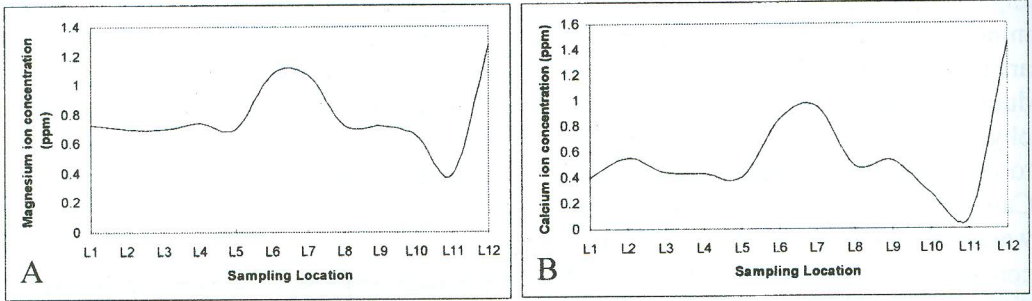
Eight major leakage outlets and several minor outlets were identified in the area where the tunnel muck has been dumped. Most of the chemical and physical parameters measured helped to conclude the similarity between the Canyon Tunnel water and the leakage waters in the area. Temperature, pH, conductivity and concentrations of different ions such as Ca^{+2} , Mg^{+2} , Na^{+} , K^{+} and Cl^{-} well correlate the similarity of the tunnel water and the leakage waters (Figure 2).

Figure 2. The graph of A.) Magnesium ion concentration at each sampling location B.) Calcium ion concentration at each sampling location

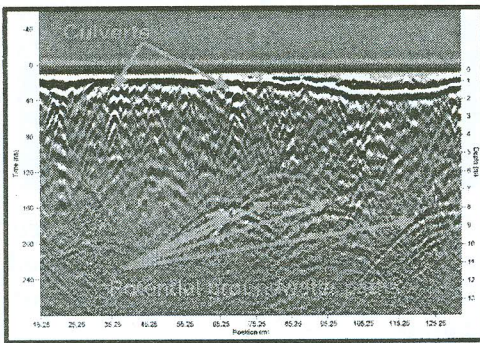
The results of the GPR survey has contributed to conclude the presence of permeable zones in the leakage outlet area (area filled with tunnel muck) that was confirmed by the previous resistivity survey data.

According to the GPR and the resistivity surveys these permeable zones are located around 6 to 12 m depth from the soil surface at the Valve House area (Figure 3).

Figure 3. GPR profile diagram showing potential permeable areas
